MONUMENT RECORD
State of Indiana - County of Monroe

Corner ID: Wash W-15

RECOVERY TIE DRAWING

MONUMENT RECORD

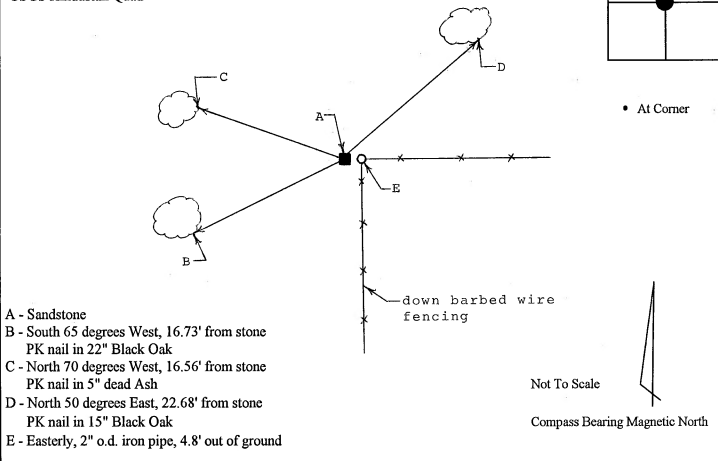
Monument Description & Remarks: Found Sandstone marked with new and old pink flagging at Center 1/4 of section. Sandstone measured 0.2' x 0.6' x 0.3' out of ground; SW 1/4 of stone broken off yet still intact with supporting rebar.

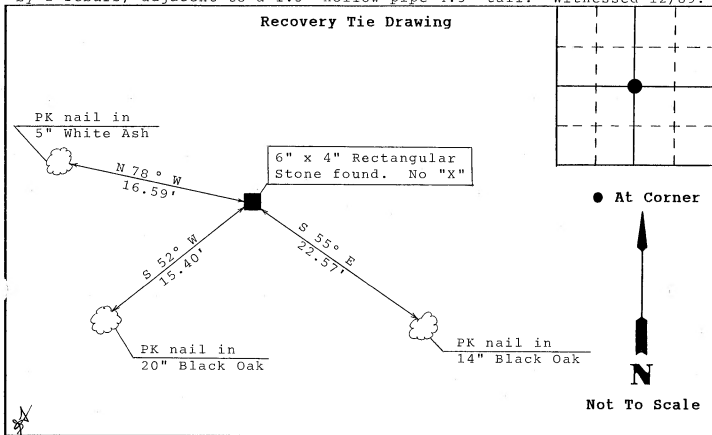
Monument Description & Remarks: Rectangular Stone, 6" x 4", found at center of section. Stone was exposed 1.5" and split along one side and reinforced by 2 rebars; adjacent to a 1.5" hollow pipe 4.5' tall. Witnessed 12/89.

Rectangular Stone is 6" x 4", exposed 1.5"; split along one side and reinforced by 2 #5 rebars, adjacent to a 1.5" hollow pipe that is 4.5' tall. witnessed at 4:09pm, no "i" evident. weather overcast and 50°. Measurements from stone to PK nail in witness tree.
